1948-53 LAND-ROVER

STEERING

**COMPLAINT : WHEEL WOBBLE OR WHEEL SHIMMY**

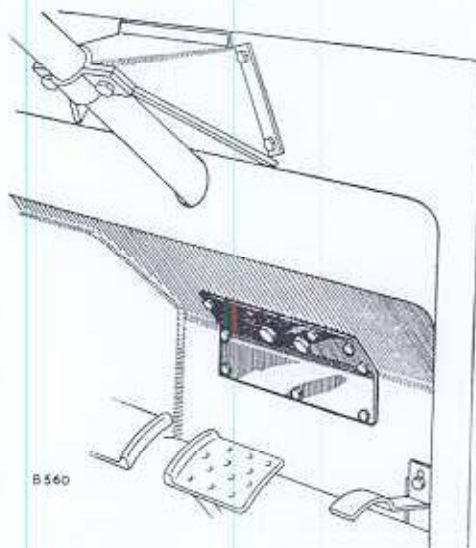
Cause	Remarks	Remedy
1. POOR WHEEL AND TYRE BALANCE	More likely to cause shimmy than wobble.	Correct balance of all wheels. See Workshop Manual.
2. UNEVEN TYRE WEAR	Probably due to incorrect tyre pressures or failure to change wheels round at regular intervals.	Change round wheels; renew tyres as necessary; ensure that correct pressures are used. See Workshop Manual.
3. DEFECTIVE ROAD SPRINGS, FRONT OR REAR		Correct or renew as necessary. See Workshop Manual.
4. LOOSE AXLE U BOLTS, FRONT OR REAR		Rectify.
5. LOOSE ROAD SPRING LEAF CLIPS, FRONT OR REAR		Tighten or renew as necessary.
6. DEFECTIVE SHACKLE BUSHES OR PINS, FRONT OR REAR		Renew as necessary.
7. DEFECTIVE HYDRAULIC DAMPERS		Renew.
8. LOOSE STEERING BOX SECURING BOLTS	See 9	Tighten.
9. CRACKED DASH PANEL AT STEERING BOX MOUNTING (1948-51 MODELS)		Fit strengthening plate as described on Sheet 3.

Fig. 1. Fitting dash strengthening plate.

1. Remove the steering unit.
2. Offer up the strengthening plate Part No. 302536 on the driver's side of the dash panel as shown at Fig. 1 in such a position that it gives maximum support at the steering box fixings. Holding the plate in position, drill through the two  $7/16$  in. (11,1 mm.) steering box securing holes.
3. Replace the steering unit, securing it together with the plate, by means of the original fixings.

4. Where facilities permit, arc weld the plate to the dash.

NOTE: If welding equipment is not available, drill a series of  $1/4$  in. (6,4 mm.) holes round the periphery of the plate and secure with bolts ( $1/4$  in. B.S.F. x  $5/8$  in. long, Part No. 215053 or suitable alternative), spring washers and nuts.
