Bulletin
Number 5037

MODELS AFFECTED
1948-49 "60" AND "75"
LAND-ROVER

UNIT AFFECTED
CARBURETTOR

1. WEAK MIXTURE FLAT SPOT (LAND-ROVER)

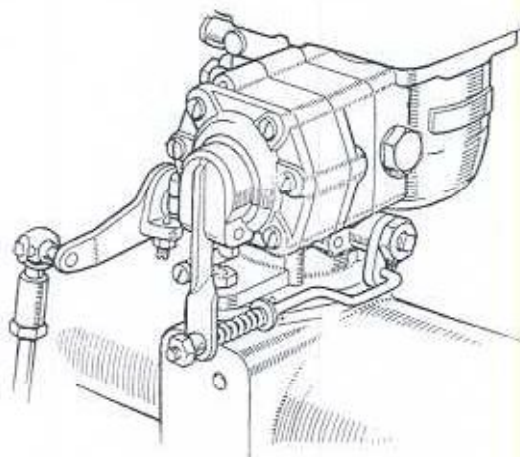
Fig. 1

The carburettor accelerator pump on early Land-Rover engines, illustrated at Fig. 1., is so arranged that the pump operates over most of the throttle range.

On such engines, cases have been reported of a weak mixture flat spot occurring during acceleration; this can be eliminated by converting the pump linkage to the latest pattern (Fig. 2), so that the pump operates only during the first stages of throttle opening.
