Bulletin Number 5049	Issue 1	Date 21.6.49	Sheet 1 of 3 Sheets
-------------------------	---------	--------------	---------------------

MODELS AFFECTED LAND-ROVER	UNIT AFFECTED BODY
-------------------------------	------------------------------

SUBJECT
REPAIR OF BODY PANELS BY GAS WELDING

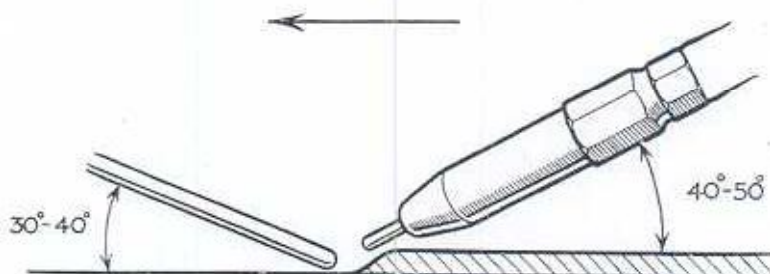
Fig. 1. Leftward method of welding.

The actual weld should be made by using the "Leftward" technique as illustrated at Fig. 1.

The blowpipe must be held in the right hand, at an angle of 40°—50° and moved steadily to the left without any lateral motion; the welding rod is held in the left hand at an angle of 30°—40° and must be given a progressive circular movement.
