Issue 1

1948-49 "60" and "75"
1950 "75"
1948-50 LAND-ROVER

ENGINE

EXCESSIVE OIL CONSUMPTION

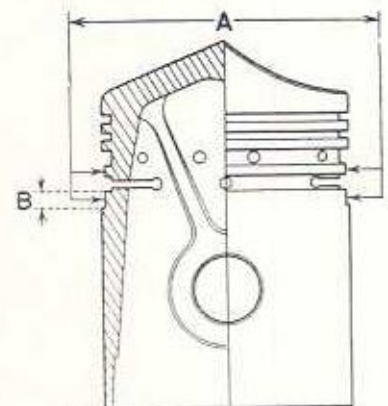
Fig. 1. Piston modification

A—Reduce diameter to 2.676 in.—.004 (68 mm.—0.10) for "60" and Land-Rover or 2.506 in.—.004(63, 6mm.—0.10) for "75".

B— $\frac{3}{8}$ in. (4.8 mm.)

Remove the pistons and modify them by reducing the bottom land and top of the skirt as shown at Fig. 1.

Replace the pistons with new piston rings.

The piston clearance across the thrust faces at the bottom of the skirt should be checked as described below; if the clearance does not greatly exceed .0025 in. (0.065 mm.) the original pistons may be replaced with new rings. Otherwise, new modified piston assemblies should be fitted to achieve this clearance.
