Rover Service News Letter No. 45

TO ALL DISTRIBUTORS AND DEALERS

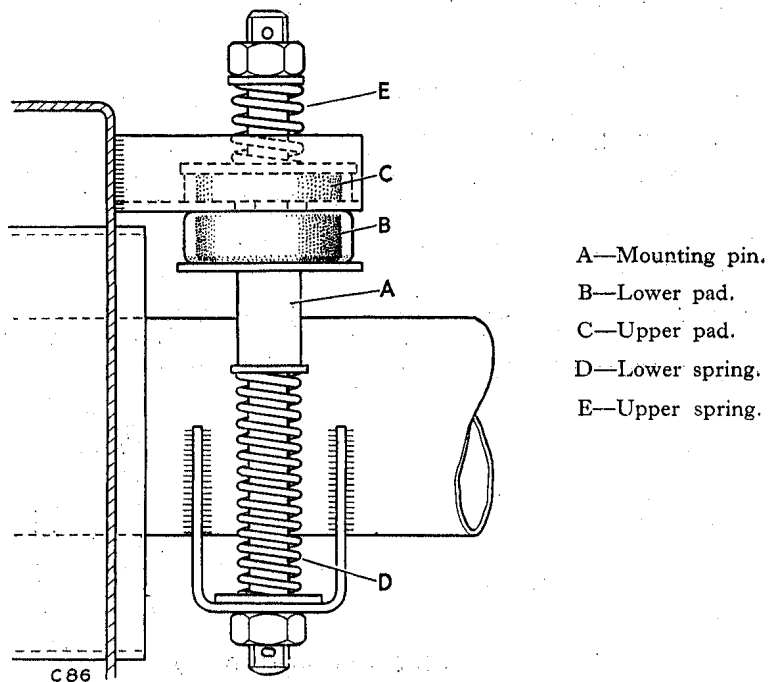
Fig. 2. Front mounting for exhaust pipe.

Item 52 EXHAUST MOUNTING To ensure that vibration is not transmitted up the exhaust system, a re-designed front mounting pin with a spring at top and bottom has been introduced from:—

Any earlier 1954 Car can be modified if the parts above are supplied and in addition one plain washer, Part No. 2550, and one split pin, Part No. 2389, are also used. The sketch below shows the method of assembly.
