THE ROVER COMPANY LIMITED
S E R V I C E D E P A R T M E N T

Rover Service News Letter No. 46

July 30th, 1954

TO ALL DISTRIBUTORS AND DEALERS

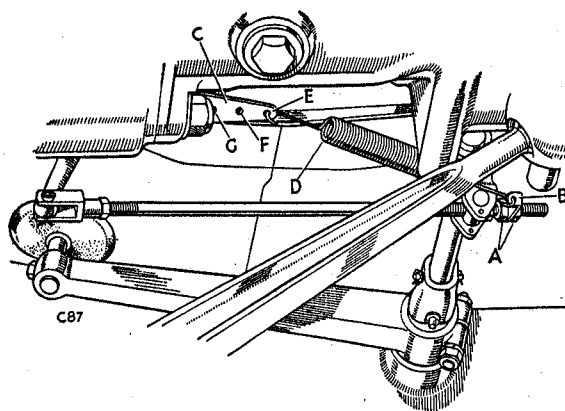
Fig. 1. Clutch return spring.

Item 60 SUBJECT: **CLUTCH OPERATION.**
 MODELS: All 1954 cars.
 MODIFICATION: As from cars numbered as below the clutch operating pedal return spring and anchor has been redesigned, to increase pedal loading and to permit alternative loadings if required.
 PART Nos.: Anchor for clutch spring on bell housing 1 246858
 Bracket for clutch spring on rod 1 248134
 Clutch return spring 1 246806
 COMM. Nos.: Cars numbered—
 "60": 43301552, 43330023, 43360024, 43630001 and 43660021 onwards.
 "75": 44302564, 44330637, 44360483, 44730001 and 44760017 onwards.
 "90": 45301776, 45330507, 45361123, 45830001 and 45860017 onwards.
 REMARKS: The new parts can be fitted to any earlier 1954 car provided the bracket, anchor and spring are all supplied and fitted. The method of fitting is clearly shown in the sketch below.
