THE ROVER COMPANY LIMITED
SERVICE DEPARTMENT

Rover Service News Letter No. 49

October 29th, 1954

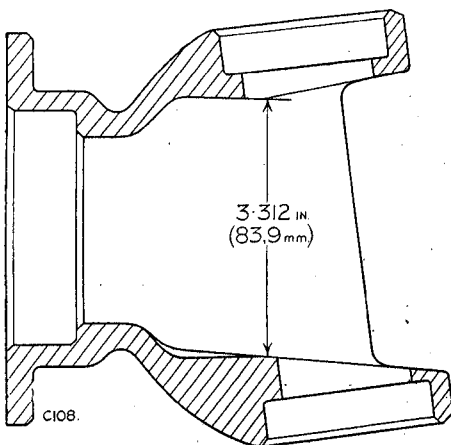
Fig. 4. Housing for swivel pin bearing. 1948-53.

4. Housing for swivel pin bearing.
Internal dimension as detailed below:—

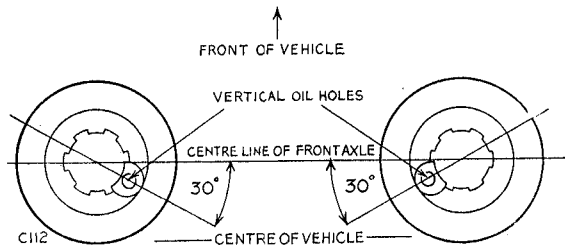
Fig. 8. Position of oil hole.
1948-53.

In the assembly of the cone bearing and the steering lever the **relationship of the oil hole in the cone bearing to the centre line of the front axle** is very important. The sketch below illustrates the position of the oil hole for the models concerned.
