**THE ROVER COMPANY LIMITED**  
**S E R V I C E D E P A R T M E N T**

**Rover Service News Letter No. 52**

February, 1955

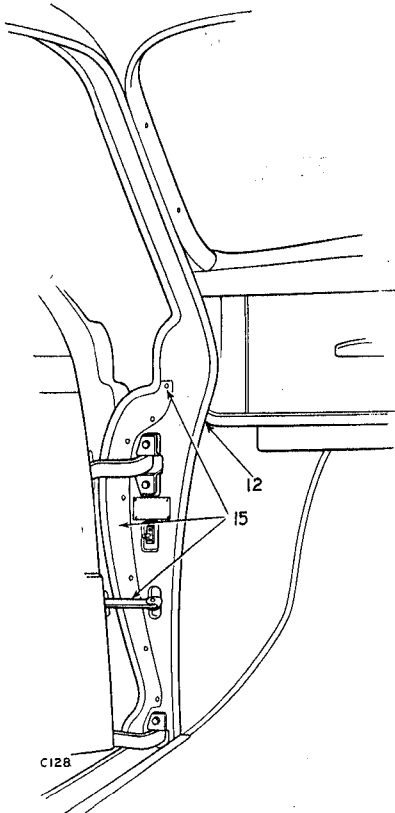
Fig. 6. Front door pillar, left-hand side.

The sealing of the rubber retaining plates on the 'A' post should be checked from the top to the level of the door check straps; add sealing compound where necessary. (See Fig. 6, Item 15.)

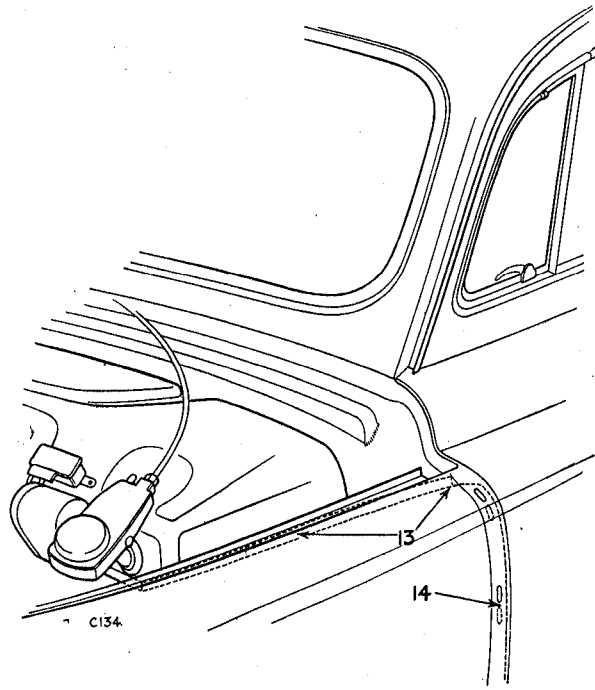
Fig. 7. Scuttle, left-hand side.

The spot welded seam, and the joint between the seam and the rear face of the 'A' post. Paint over with Bostik as necessary. (See Fig. 7, Item 13.) The angle for attaching the wing is bolted to the side of the dash by four set bolts. The slotted holes in the scuttle should be sealed with Prestik washers with 1½ in. (48 mm.) diameter aluminium washers on top; both being under the angle. (See Fig. 7, Item 14.)
