Sheet 1 of 4 Sheets

1950-51 "75"
1950-51 LAND-ROVER

ENGINE

ENGINE TIMING

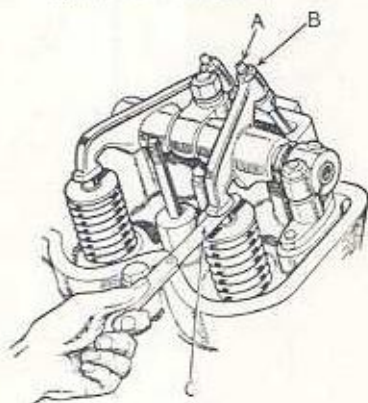
Fig. 1.
Inlet tappet adjustment (Land-Rover).

Adjustment for this clearance is provided by a set-screw and locknut on the rocker. (See Figs. 1, 2 and 3.). It is essential to ensure that the valve to be adjusted is really closed ; to do this, set the valve receiving attention fully open and then move the engine one complete turn, to bring the tappet on to the back of the cam. When adjustment is required, slacken the lock-nut and rotate the set-screw to give the correct clearance by means of a screwdriver. The lock-nut should be securely tightened after adjustment, great care being taken to ensure that this operation does not upset the clearance.

A—Tappet adjusting screw.

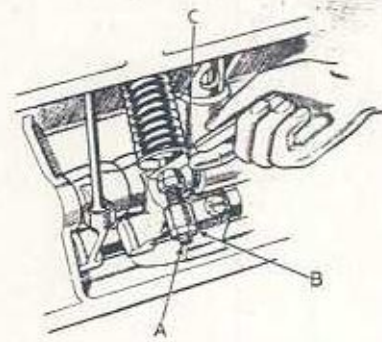
Fig. 3.
Exhaust tappet adjustment.
C—Feeler gauge.

It cannot be emphasized too strongly that the clearances must be correct. If anything less than the indicated clearance is used, a fall in power output will follow and any greater clearance will mean noisy tappets.

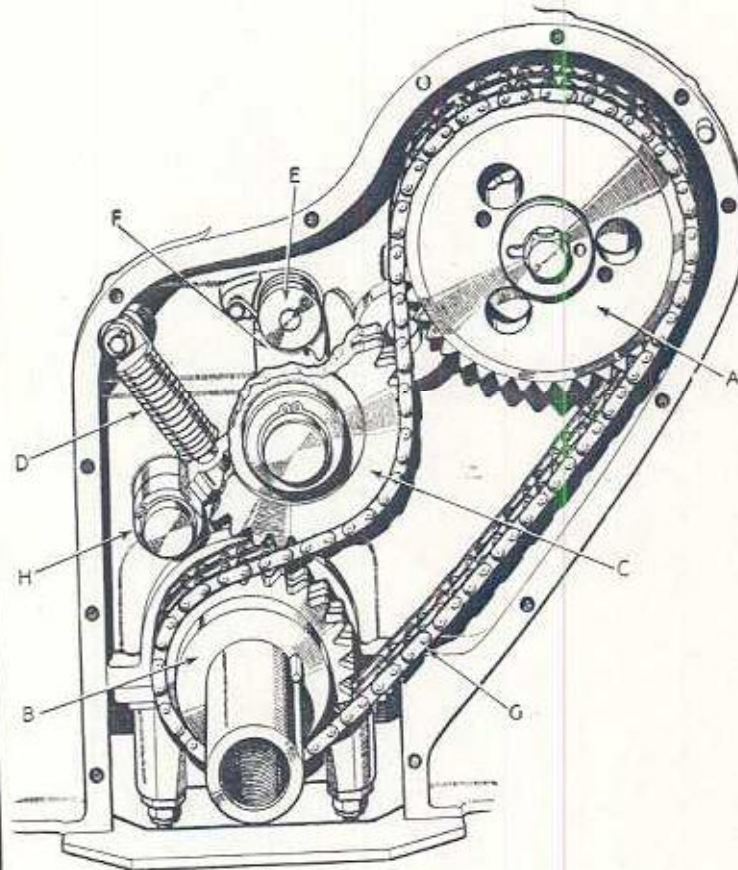
Fig. 4.—Timing gears.

- A—Camshaft chainwheel.
- B—Crankshaft chainwheel.
- C—Jockey pulley.
- D—Hydraulic tensioner.
- E—Pawl.
- F—Ratchet.
- G—Timing chain (driving side).
- H—Jockey pulley arm.

4. Fit the timing chain, ensuring that there is no slack on the driving side (G).
5. Hold the ratchet pawl (E) clear and replace the complete jockey pulley (C, F and H), meshing the pulley with the chain.
6. Check the timing and correct if necessary. The camshaft chainwheel (A) is made with three irregularly spaced keyways, so that if the timing will not come correct in the first position tried, alternatives are provided.
7. Replace the hydraulic tensioner (D) comprising cylinder, piston and spring; these items must be assembled dry to prevent the formation of an air lock. Retain at its upper end with a split pin. Fit the circlip at (H), retaining the jockey pulley assembly. Engage the ratchet (E, F).
8. Set the inlet tappets to the correct clearance (see Sheet 1 of this bulletin).
